Long Road Racing

Global MX-5 Cup Car Technical Service Bulletin #2-28-17A

REQUIRED: 2017 Global MX-5 Update: ECU Firmware and Calibration File Update

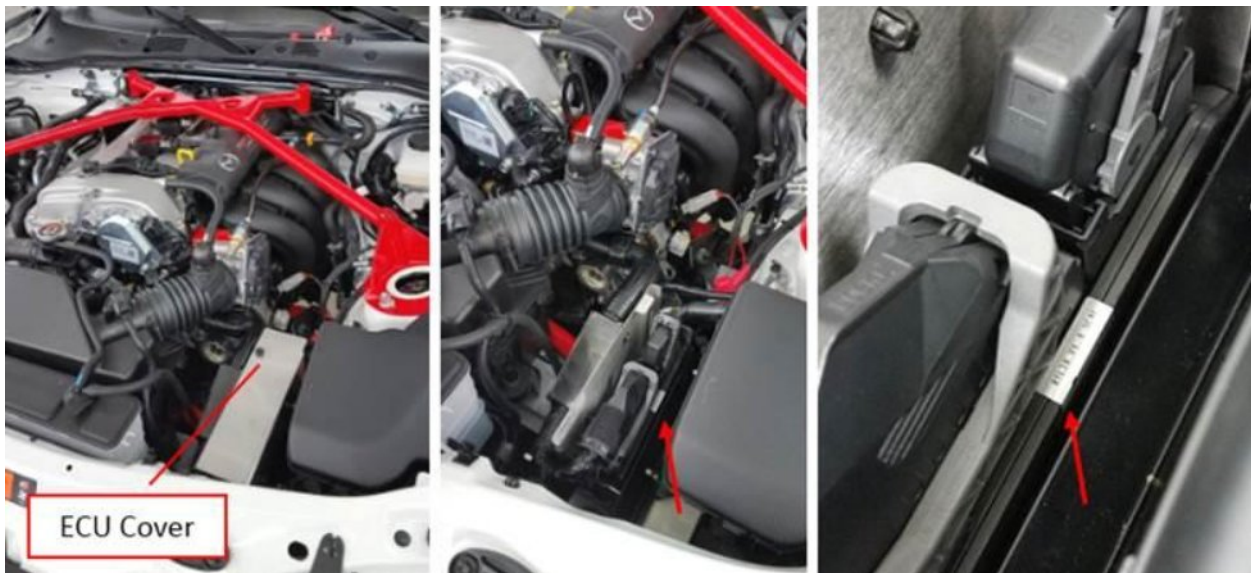
Lastly, you must have your ECU updated to the new 01L30 firmware before updating your AiM configurations to the new driver. The new driver will not properly report ABS errors with the now outdated 01L15 firmware.

You can identify which firmware your ECU has on it by a sticker shown on the top edge of the ECU as shown below.
