Competitor Information Bulletin #2026-06-07 - Recommended Replacement of Smaller Bypass Cap

Date: June 07, 2025

Affected Models: All model year vehicles

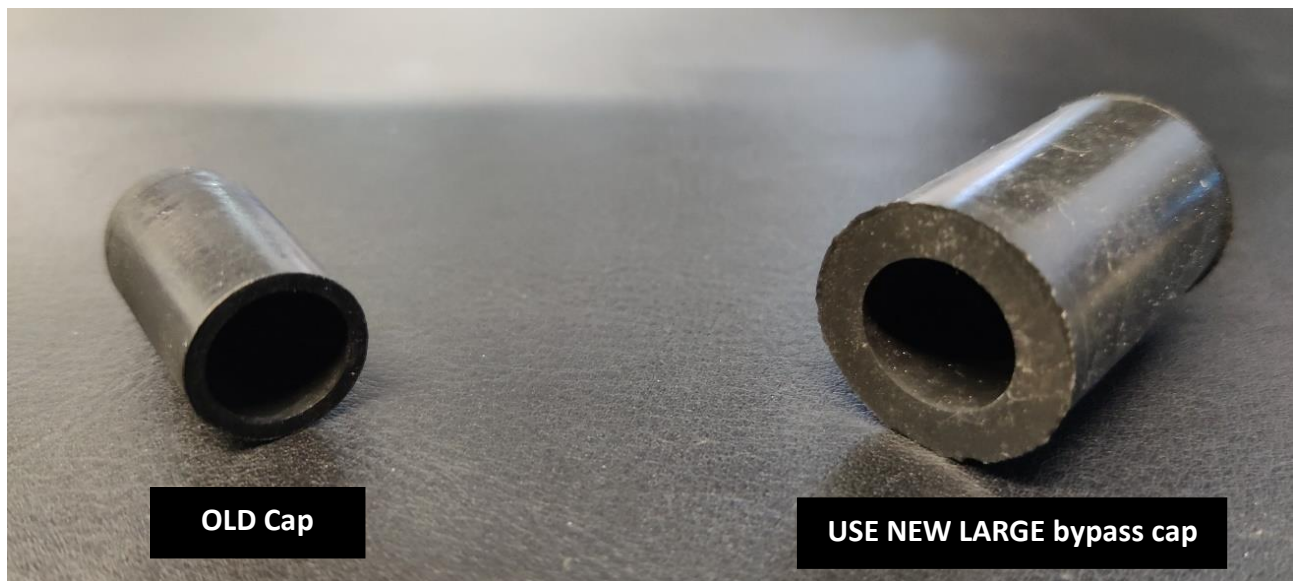
Location: Thermostat/Water Pump Housing Nipple. Secure with Hose Clamp.

Flis Performance strongly recommends proactive replacement of the smaller/thinner of the two bypass caps with the updated, more rigid version. The revised cap maintains the same form, fit, and function while offering significantly improved pressure-handling capability and structural integrity.

1. Safely relieve system pressure and drain fluid as required by the applicable service manual.
2. Remove the existing smaller bypass cap.
3. Install the new rigid bypass cap with provided hose clamp
4. Refill and bleed the system per standard procedure.
5. Pressure test the cooling system to verify integrity.
