## Global MX-5 Cup Car Technical Service Bulletin #06-27-2017

**REQUIRED:** 2017 Global MX-5 Update: **Cooling hose clamp** update effective immediately

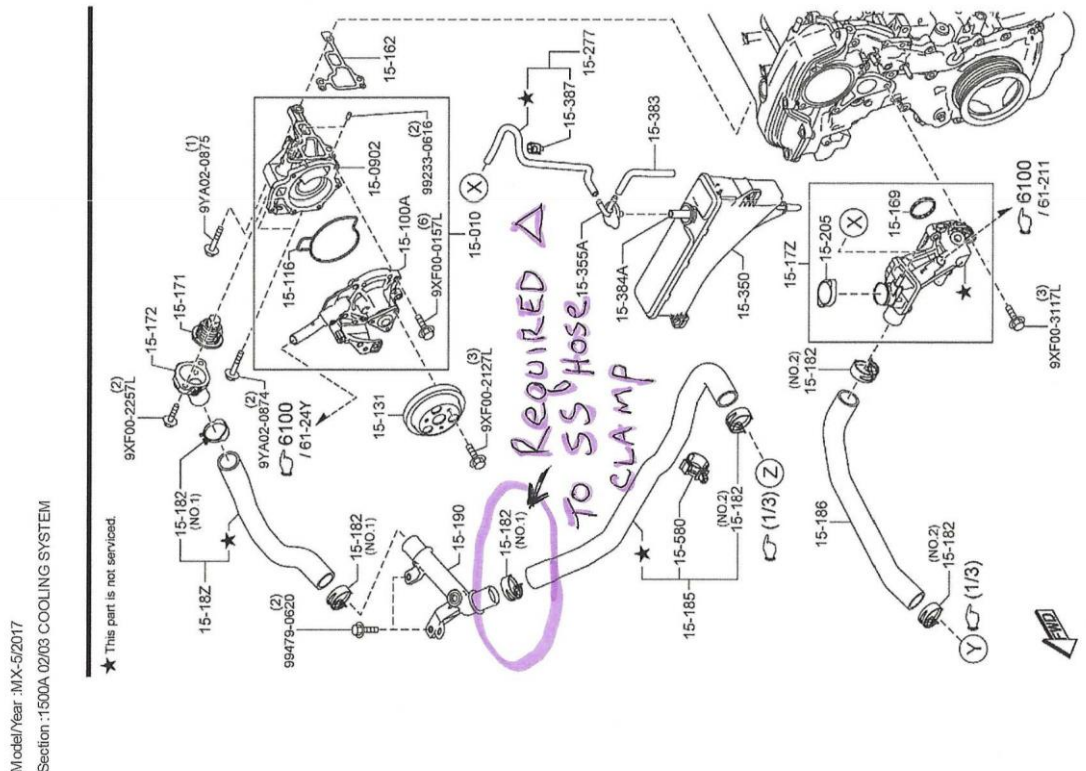
Diagram:

1. A chance of the lower radiator hose clamp may become dislodged (see diagram). The factory spring style clamp is being replaced with a standard stainless steel screw style clamp. **This ONE clamp is a mandatory change**, but all other water hose clamps may be changed to a stainless steel screw style clamps at your option. Purchase the clamp(s) locally.

1. Follow all Mazda service manual instructions for safety, removal and replacement of the water hose clamp(s).
