## Mazda MX-5 Cup Car Technical Service Bulletin #2022-04-14

### Optional: Mazda MX-5 Cup Radiator Cap Safety Wire Hole(s)

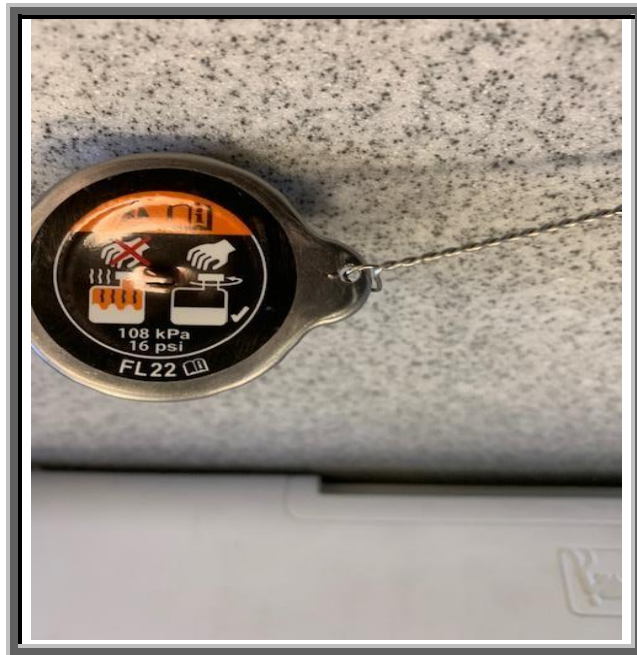
The purpose of this TSB is to allow competitors to drill a hole in each ear(s) of either homologated radiator cap per the picture below. The competitor may then safety-wire the cap if desired. No other modifications to the radiator cap or use of the safety wire is permitted.

**Competitors are solely responsible for attaching the safety wire properly. If the wire is attached to the upper water hose clamp, we encourage competitors to ensure the clamp is tight. We have seen teams that have not tightened the clamp properly and this resulted in upper hose failure.**
